CRUISE REPORT¹

VESSEL: *Hi'ialakai*, Cruise HI-06-14

CRUISE PERIOD: November 08-13, 2006

AREA OF OPERATION: Kalohi, Pailolo, and Auau Channels between the Islands of Maui County and the west coast of Hawaii Island

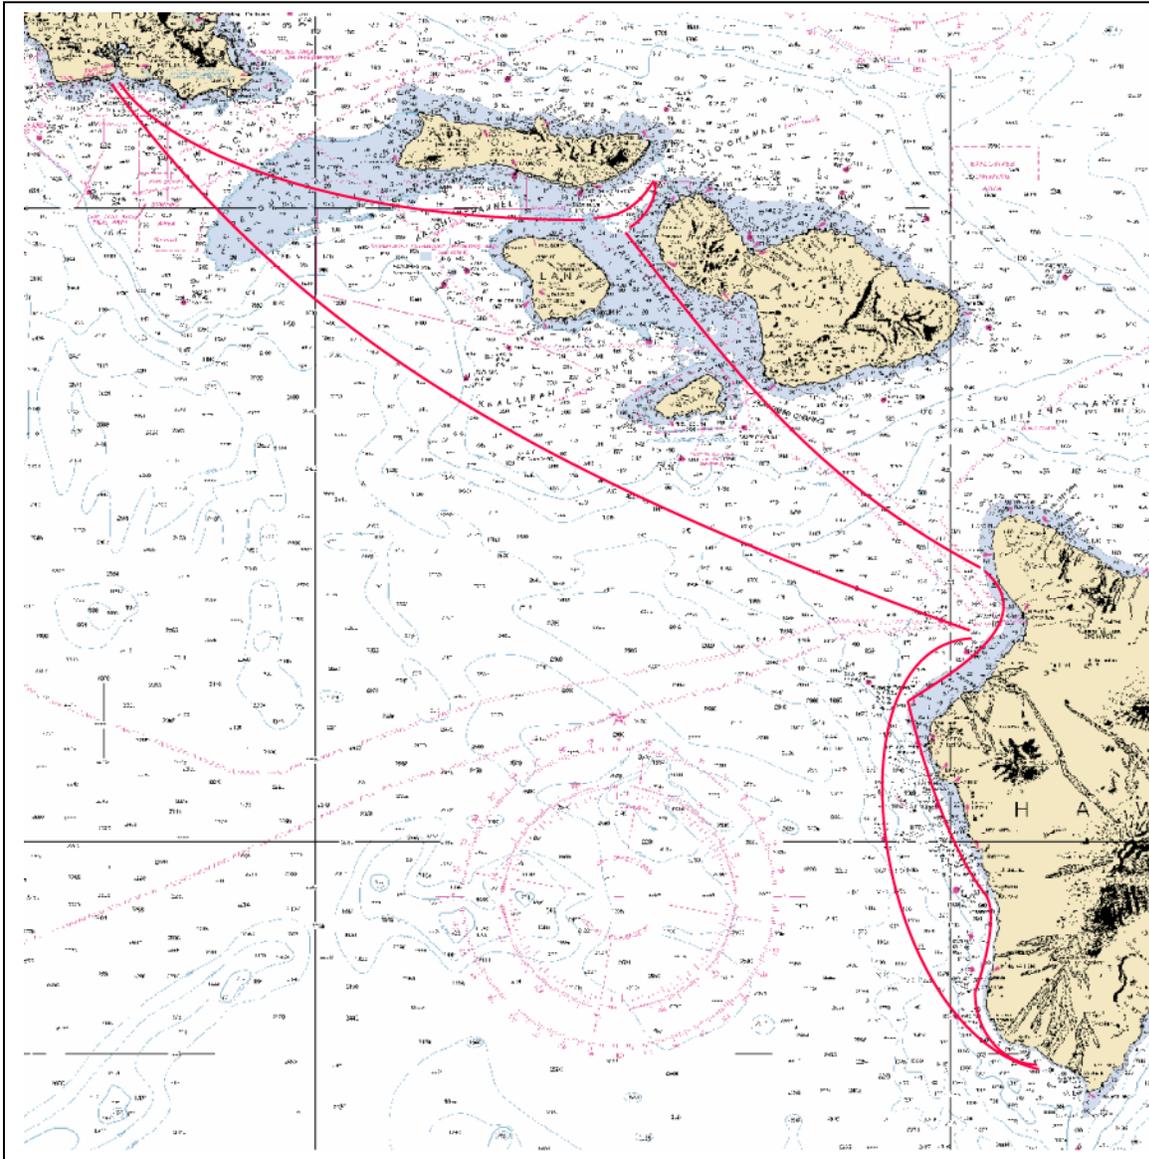
Figure 1.--Track of the NOAA ship *Hi'ialakai* Cruise HI-06-14, November 08-13, 2006.

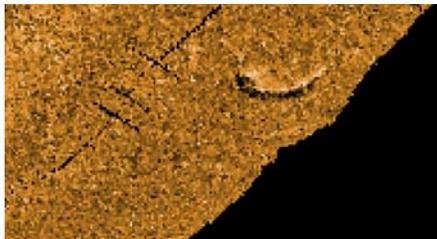
1a) Laser image prior to processing (5 cm pixel size). The semicircular object may be the shadow of a fish.

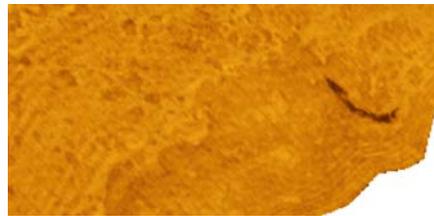
1b) The same laser image, after processing with OIC's Clean Sweep software.

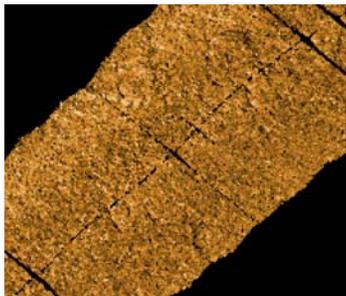
2a) Another laser image prior to processing (5 cm pixel size).

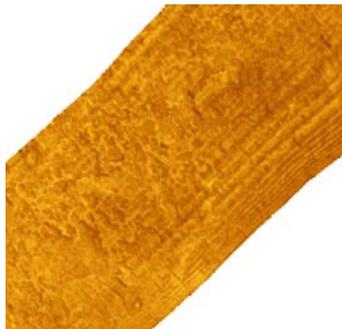
2b) The same laser image, after processing with OIC's Clean Sweep software.

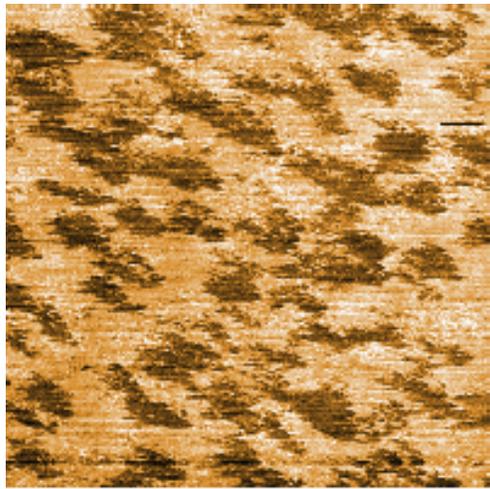
3) Unprocessed image of *Halimeda* sp. algae meadow.

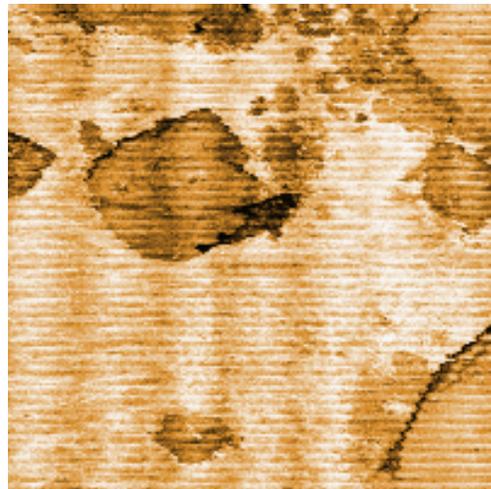
4) Unprocessed image of a large fish near a boulder on the seafloor.

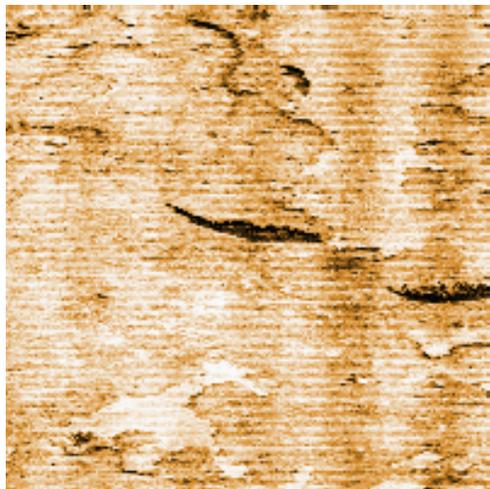
5) Unprocessed image of a fish and its shadow over a rocky seafloor.
